FAILURE IN GENERATING DATA FILE DURING AXIOM™ MICROARRAY GENOTYPING: IDENTIFICATION OF CAUSES AND PROBABLE SOLUTIONS

National Dairy Development Board
Anand, Gujarat - 388 001
India

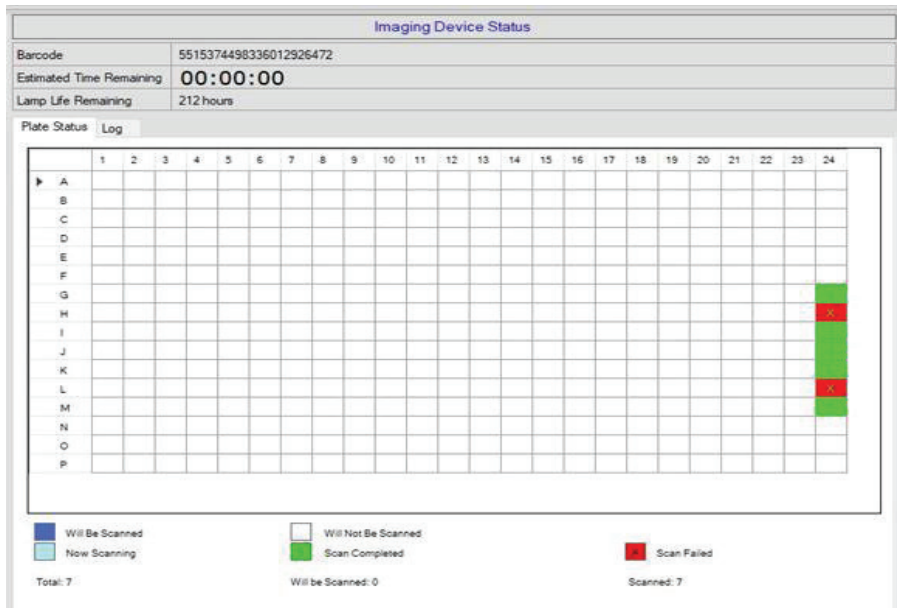
The most common error was failure of the GTMC scanner to capture data from certain array pegs, resulting in missing .CEL files. Overall, .CEL files were not generated for a total of 276 samples, including 18 samples genotyped with Mini-96 (96F) workflow across 12 genotyping batches, and 258 samples processed with Axiom™ Propel (384F) work flow across 44 genotyping batches. At the end of each genotyping batch, GCC software displayed the scan results (figure 1). The pegs that

were scanned successfully were seen as green coloured squares, whereas the pegs that failed were red coloured and .CEL files were not generated for such samples. Table 1 summarizes potential causes and probable solutions.

Fig.1. GCC software Scanner Status : Red coloured squares with “X” mark are samples that failed in scanning (H24 and L24) and green colored squares with “S” means these pegs were scanned successfully with a .CEL file generation (G24, I24, J24, K24, and M24).

Error-1	Scan failed in GTMC
Possible reasons	<ol style="list-style-type: none"> 1. After completion of staining step, the array plate was stacked on the scan tray filled with hold buffer, within GTMC instrument by the robotic arm, submerging all the pegs in the hold buffer. This might have created air bubbles at certain locations which may interfere with the subsequent scanning process. 2. Sometimes, any particulate matter may get adhered to the bottom surface of the scan tray, interfering with the scanning process.
Probable solution to overcome it	<ol style="list-style-type: none"> 1. The array plate was carefully dislodged from the scan tray by placing them in the plate alignment tool. The array plate was moved upwards in a straight motion and then the scan tray was slightly jiggled. Any air bubbles were burst with a sterile micro-tip and then the array plate was again placed on the scan tray in correct orientation. 2. The bottom transparent surface of the scan tray was cleaned with a kimwipe and placed in GTMC instrument for rescan. <p>By following the above method, 256 .CEL files were generated after rescanning 276 pegs, which were failed in initial scanning. This way 92.75% .CEL file were generated successfully. Remaining 20 pegs were rescanned 3 to 4 times, but did not generate any .CEL files. These 20 pegs did not generate any .DAT files, therefore the error investigation was not possible.</p>

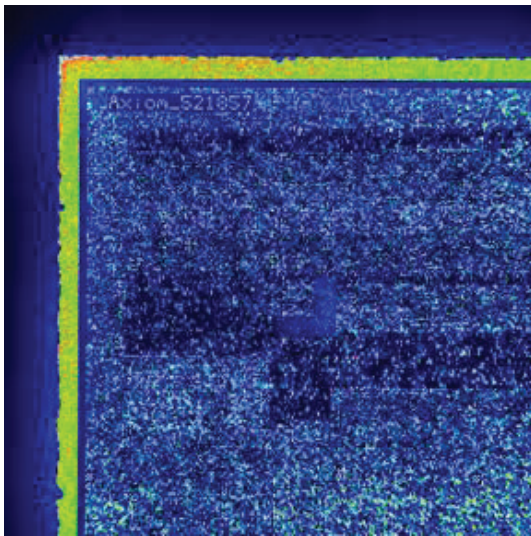
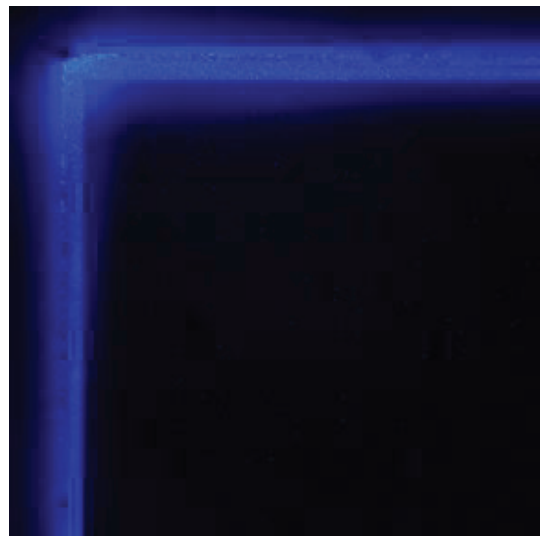
Error-2 was identified by files with .DAT extension. These files were visualized using “GCC Viewer” of the Gene Chip Command Console Software. A .DAT file is a binary raw image data file, which contain pixel intensity values collected from the Affymetrix scanner, along with the gridding information used during feature extraction. Whereas .CEL files store the results of the intensity data on the pixel values of .DAT file. The comparison of the .DAT file image for a sample with successful .CEL file generation and for a sample with no .CEL file generation with the “GCC Viewer” is shown in figure 2.

Figure 2 shows the real time .DAT image of a scanned peg of an array. In (a), thousands of different coloured spots are seen distributed throughout the image, which represents the light emitted by laser excited fluorescent probes attached to the

oligonucleotides tiled on the peg of the array. Whereas in figure 2 (b), a uniformly dark coloured area is seen without any spots.

Fig.2. Representative image of a peg of the Affymetrix microarray plate generated in the Gene Chip® Command Console software (.DAT format). (a) The image displays a raw scan of the microarray peg surface, where each small fluorescent dot corresponds to an individual oligonucleotide probe set immobilized on the array. The fluorescent signal intensity of each dot reflects the degree of hybridization between the target nucleic acids and the probe, forming the basis for subsequent genotyping and analysis. The whole image represents successful .CEL file generation for a single sample, and (b) a raw scan image of a microarray plate peg surface for a sample with no .CEL file generation indicating complete absence of fluorescent probe signals. The uniformly dark appearance indicates a lack of hybridization.

Probable solution to overcome it	<p>A thorough inspection can be performed to determine whether any incorrect well loadings exist after dispensing hyb-ready DNA or stain reagents to a 384-well plate.</p>

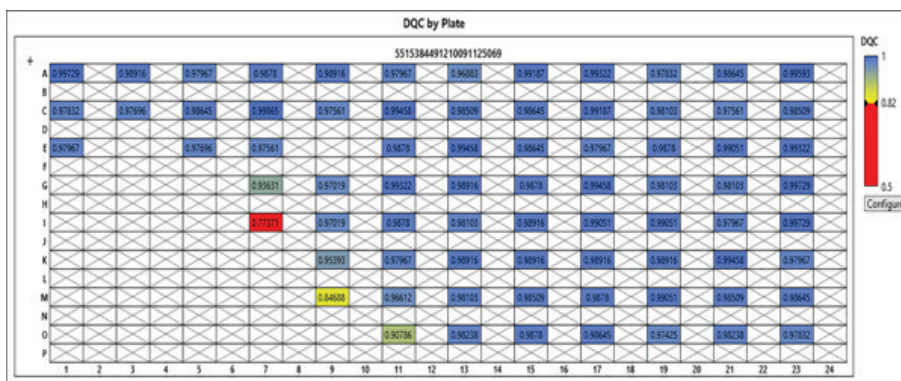
In one Mini-96 (96F) genotyping batch, .CEL files were missing for 21 out of 96 samples. Rescanning the array twice ruled out peg scan failure (Error 1), and visual inspection of the plates ruled out reagent misdispensing error (Error 2). The error was mysterious until all the .CEL files were analysed in the Axiom™ Analysis Suite application (AxAs). The plate view function of AxAs revealed a triangle region at the bottom left corner of the array plate (figure 3). This region contained all pegs of 21 samples for which .CEL files were not generated. Tracing this error to its root unveiled the clamping related issue. Clamping is a process that involves stacking the array plate above the hyb-plate on a flat surface of a table and giving equal pressure on 6 different positions until a clicking sound is detected. Table 3 outlines the possible reasons along with suggested solutions for error-3.

Fig.3. Plate View of Dish Quality Control (DQC) values generated after analysis of .CEL files from a mini-96 Affymetrix microarray plate in the AxiomTM Analysis Suite software. Each well corresponds to an individual sample, with the color scale representing DQC scores ranging from 0.5 (red, poor quality) to 1.0 (blue, high quality) with 0.82 being the threshold value. DQC is a key QC parameter that reflects quality of input DNA samples. Most wells across the plate exhibit high DQC values (>0.97), indicating robust performance. However, 20 wells located in the bottom-left corner of the plate show missing data and 3 samples with low DQC values, suggesting localized failure. This clustered pattern may be attributed to technical factors such as pipetting or dispensing errors or uneven plate clamping issue.

Error-1	Improper clamping of array plate with hyb-plate
Possible reasons	While clamping, if equal pressure was not applied at all 6 positions on the array plate, then the array plate may not get attached properly to the hyb-plate.
Probable solution to overcome it	<p>The array plate and hyb-plate were loaded separately into GTMC instrument and stacking of array plate over hyb-plate was performed by the robotic arm within GTMC instrument. At this point, the clamping must be performed manually, outside the instrument.</p> <p>The array plate-hyb plate combo was placed on a flat surface of the table and all 6 positions were pressed with equal and sufficient pressure to detect the clicking sound. After clamping, the combo was lifted to the eye level and observed for any space between them. If any gap was seen at any position, then it was again pressed at that point by keeping it on a flat surface.</p>
