Ventral Hernioplasty in a Pulikulam Racing Bull – A Case Report

Madeena Begum, M., N.Krishnaveni, M.Revathi, M.Balagangatharathilagar and E.Madhesh

Veterinary Clinical Complex, Veterinary College and Research Institute, TANUVAS, Tirunelveli-627538.

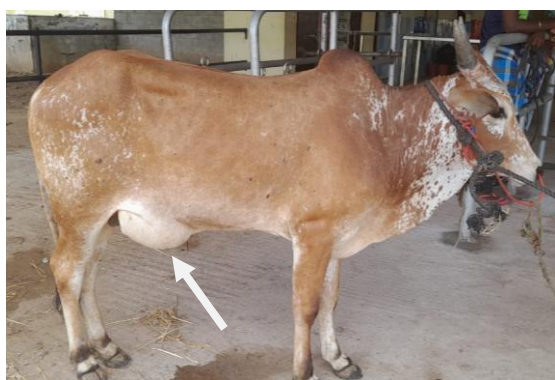
An year old pulikulam bull was presented to Large Animal Surgery Unit of Veterinary Clinical Complex, Veterinary College and Research Institute, Tirunelveli, with a past history of gore injury. Upon physical examination reducible hernia on the ventral abdomen was noticed (Fig.1). Clinical examination revealed no

Fig. 1: Pre-operative picture (arrow) showing ventral hernia

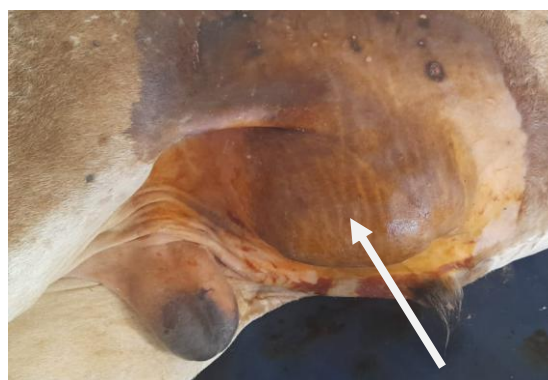
Fig. 2: Arrow showing pre-operative preparation of surgical site

Animal was restrained physically and the surgical site was aseptically prepared by shaving of hairs and scrubbing of the site with 7.5 % povidone iodine and surgical spirit (Fig.2). General anesthesia was achieved with injection Xylaxine 0.1 mg / kg IM, Inj. Butorphanol 0.02mg/kg IV, inj. Ketamine 0.5 mg/kg IV as preanesthetic agents and induction and maintenance with inj. ketamine 0.5 mg/kg IV, animal was positioned it left lateral recumbency. Hernial ring was palpated and a linear skin incision was made on the top of Hernial ring. Hernial sac was dissected and blunt dissection was made on subcutaneous tissue. A small incision was made on hernial sac and hernial content was examined which was the loops of small and large intestine without any change and adhesions (Fig.3). The intestine was pushed in and it was lavaged with normal saline. The intestine was repositioned to its original position. Hernial ring was resected (Fig.4) and overlapping suture was done by polypropylene 1 (Fig.5). The suture was placed using Polypropylene mesh size 30cmx30cm. It was placed on the top of Herniorrhaphy area. Hernioplasty was done by suturing the mesh with abdominal muscle with Polypropylene 1.0 (Fig.6). Subcutaneous suture was done over the mesh by using PGA 1.0. The skin was closed by cross mattress with prolene 2.0. Post

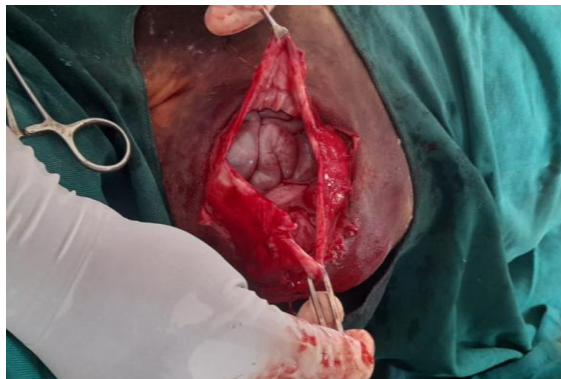
Fig. 3: Intra-operative picture showing the hernial sac with the content

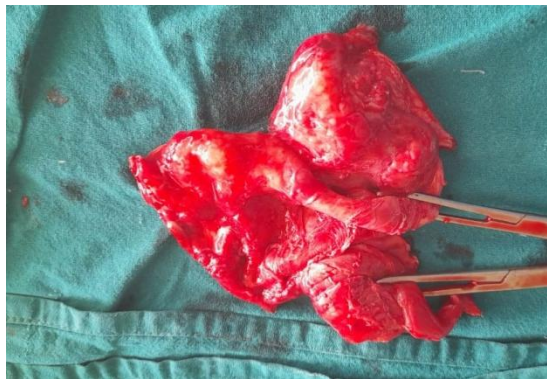
Fig. 4: Picture showing resected hernial sac

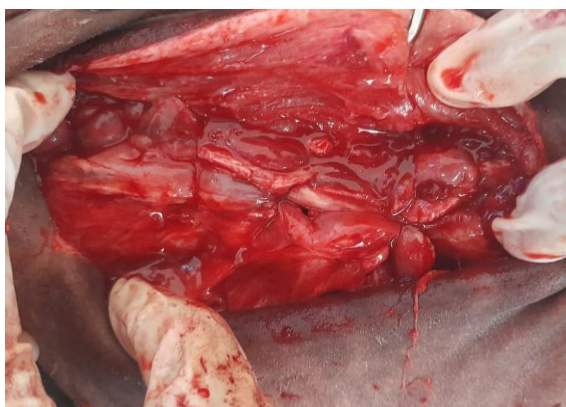
Fig. 5: Intra-operative picture showing herniorrhaphy performed by overlapping sutures with Polypropylene size 1

Hernia can be surgically corrected either by herniorrhaphy or by hernioplasty. Herniorrhaphy is usually performed in cases which has small hernial ring, where the hernial ring is resected and overlapping sutures were made (Ragunath *et al.*, 2017). In case of large hernial ring the defect is large and simple herniorrhaphy is not strong enough to prevent reoccurrence. In such cases hernioplasty with the help of synthetic non-absorbable meshes are used to provide extra support to the body wall and in turn prevent the reoccurrence (Singh *et al.*, 2012). In our case the bull was used for professional racing, hence to give a double layer protection, herniorrhaphy was performed first followed by hernioplasty was done on top of the sutured area in such a way that the mesh covering the herniorrhaphy suture line

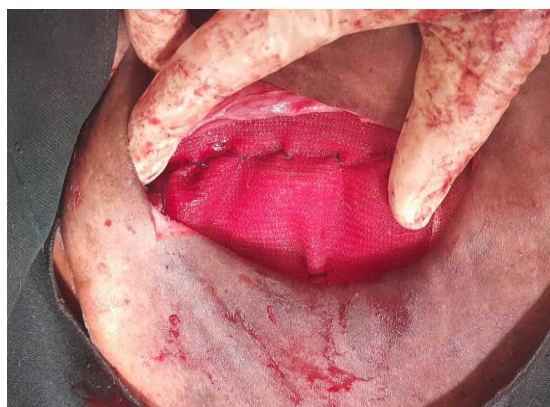
Fig. 6: Intra-operative picture showing hernioplasty performed over the herniorrhaphy suture using Polypropylene mesh

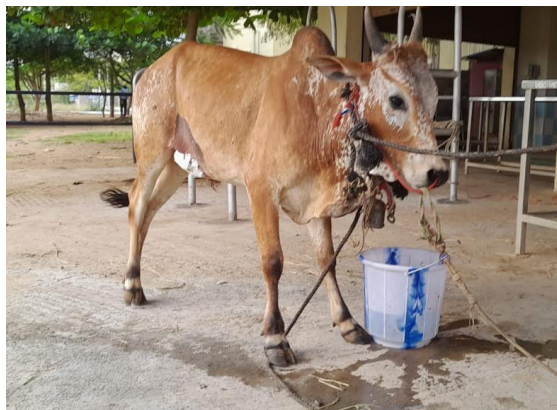
Fig. 7: Post-operative picture showing corrected ventral hernia

operatively the animal was treated with Inj. Ceftriaxone 10mg/kg intramuscularly for 7 days. Owner was advised to do antibiotic wound dressing. Sutures were removed on 10th post operative day, after the complete healing. Bull made an uneventful recovery (Fig.7 & Fig.8).

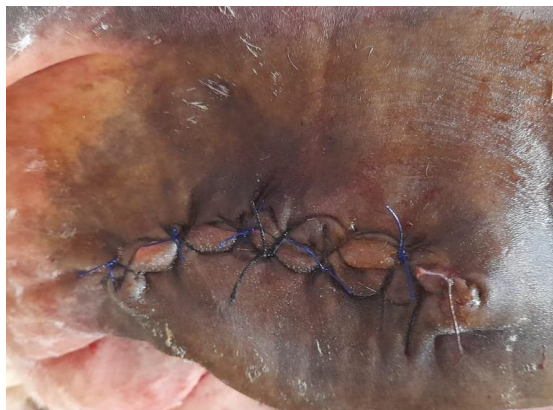
Fig. 8: Post-operative picture showing complete healing of the sutured site
