# EXPERIMENTS WITH FIBRE-GLASS SHEATHING AS A PROTECTION AGAINST MARINE WOOD-BORING ORGANISMS

R. BALASUBRAMANYAN

Central Institute of Fisheries Technology, Craft & Gear Wing, Cochin-5

Wooden test panels of different species of wood sheathed with fibre-glass reinforced plastic were subjected to immersion tests along with corresponding controls in Cochin Port area and the effect of the protective coating studied.

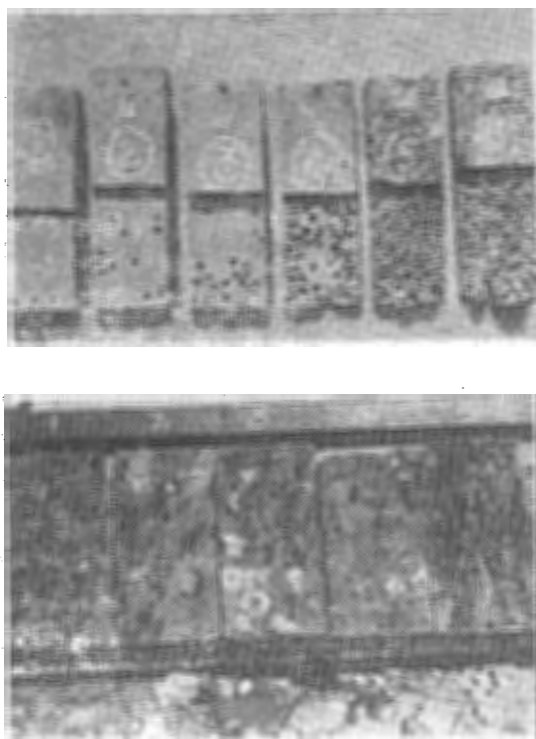
Fig 2 & 3. Pattern of marine borer attack on unprotected wooden test blocks (control) at the C. I. F. T Test Site, Cochin.

The unsheathed controls exhibited the first evidence of borer attack during the second inspection in the month of October as revealed by the presence of surface holes. The borer attack appears to have been initiated on the unprotected controls roughly between 40 and 45 days of immersion. At every inspection it was observed that the attack of the marine wood borers on the unprotected controls were on the increase and before 6 months were completed, more than 50% damages were noted on them (Figs, 2 & 3). The fibre glass sheathed wooden test panels were however free from any damage. The timber damages were caused mostly by *Martesia striata* (80%) and to a lesser extent by *Nausitora*

*hedleyi* and *Teredo furcillatus* (20%). As regards the hydrographical features at the test site, salinity of the water appears to have the greatest influence on the marine boring and fouling organisms. From November onwards till May the salinity of the water was steadily increasing and simultaneously the quality and quantity of the marine organisms were on the increase as observed previously by Balasubramanyan (*loc cit.*) and Nair (1965). It was interesting to note that the acorn barnacles, *Balanus amphitrite*, which are known to plough into paint coatings with the sharp growing edges of their shells could not do so with the fibre-glass sheathing though they were settling on them in large numbers.
